## SERVICE REPORT

Major Overhaul 18K

February 2014

ACP – Miraflores Power Station

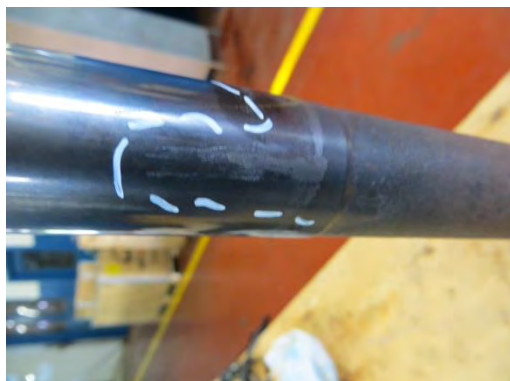
Exhaust valves: 20 pieces were rejected; of these, 12 valves had scuffing marking on the stem, 6 had pitting marking in the lower area of the valve, 1 had a too large burn away area, and 1 was found with a high run out. See enclosure No. 3.

Exhaust valve with scuffing markings

The specialist concluded that the valves could not be used for further operation, which was in line with BWSC's recommendation.

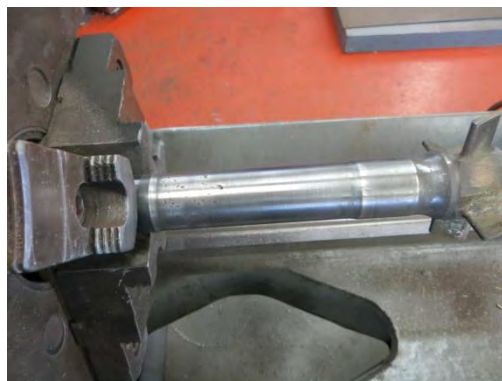
Exhaust valve with pitting markings

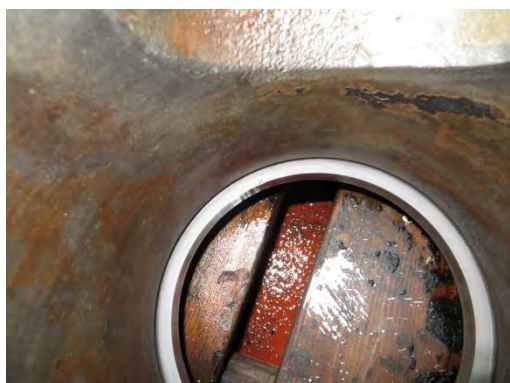
The following cylinder heads were rejected; A2, A4, B2 and B7 due to the landing surface of the exhaust cage being worn down below the limit.

The grey ring is the landing surface for the exhaust valve cage.

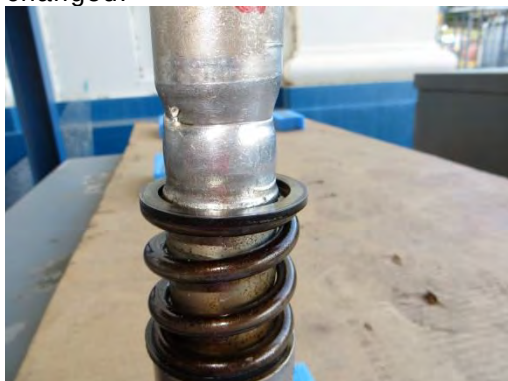
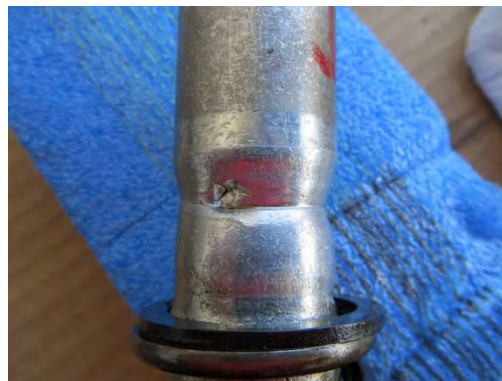
Of the 18 guide shoes, 8 were found in bad condition. ACP ordered all of them changed.

Guide shoe

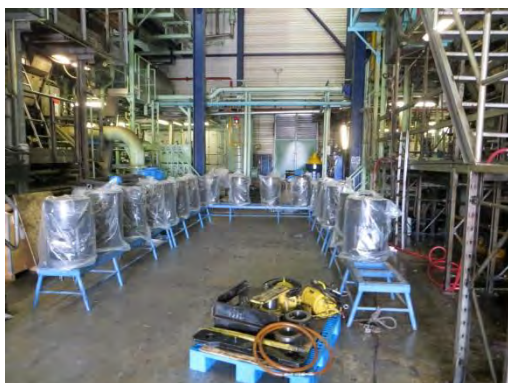
The pistons were installed with new skirts and new piston rings.

All pistons ready for installation

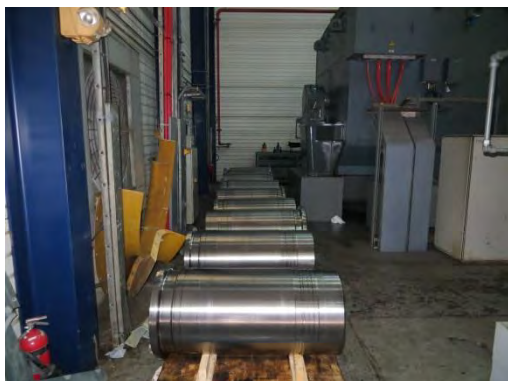
New liners ready for installation.

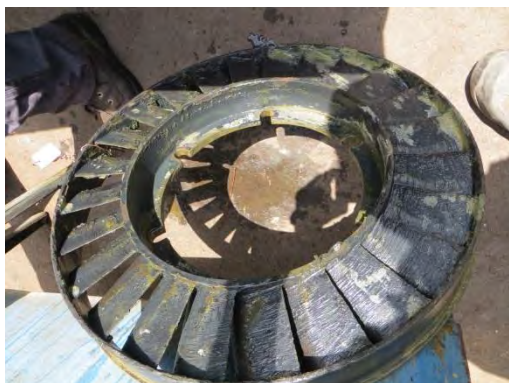
The nozzle rings were very dirty and were put in a water bath for several days. The final cleaning was done by means of sandblasting. Both nozzle rings were crack tested by NDT method dye-check. No cracks were found.

Nozzle ring before cleaning

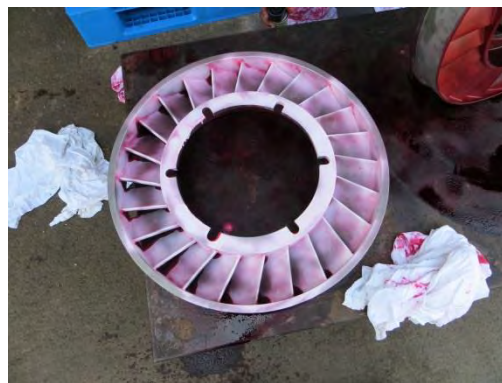
Dye-check

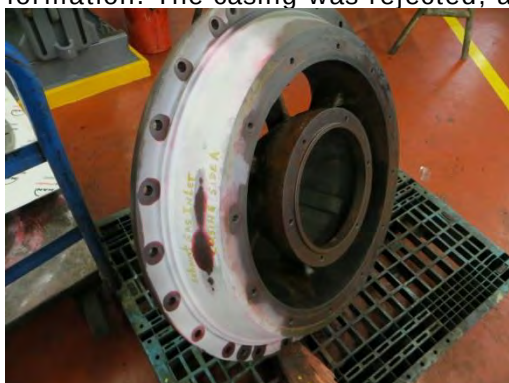
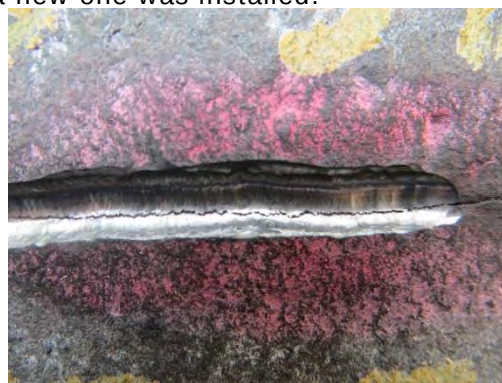
The gas admission casing from "A" side turbocharger was found with a crack formation. The casing was rejected, and a new one was installed.

T/C "A" gas admission casing

Crack close up after exposure grinding

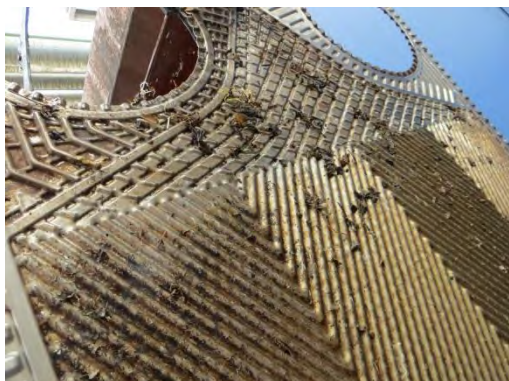
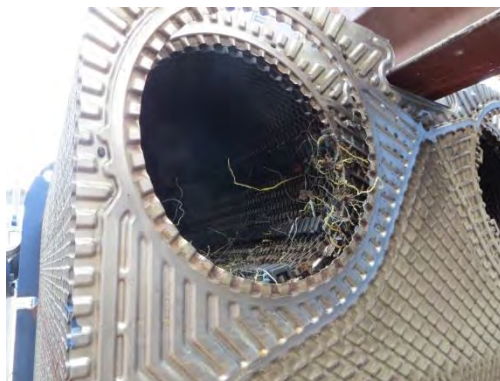
The central cooler was dirty but still in good condition. The latest inspection of the cooler was made in July 2009.

Plate on lake water side

Dirt on inlet side

All plates were cleaned and removed from the unit for final inspection and to install new gaskets.

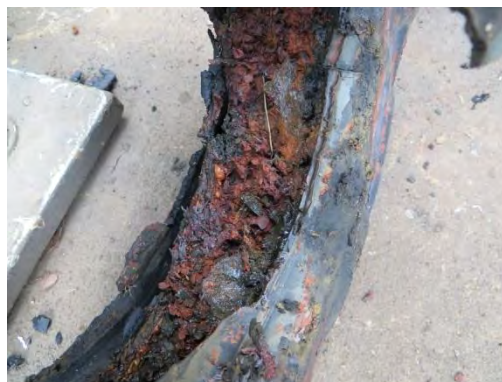
The spacer ring between the water line and the cooler are in corroded condition. They have been put back as no new ones were available, why new ones need to be ordered for next overhaul.

Spacer ring in bad condition

Close up

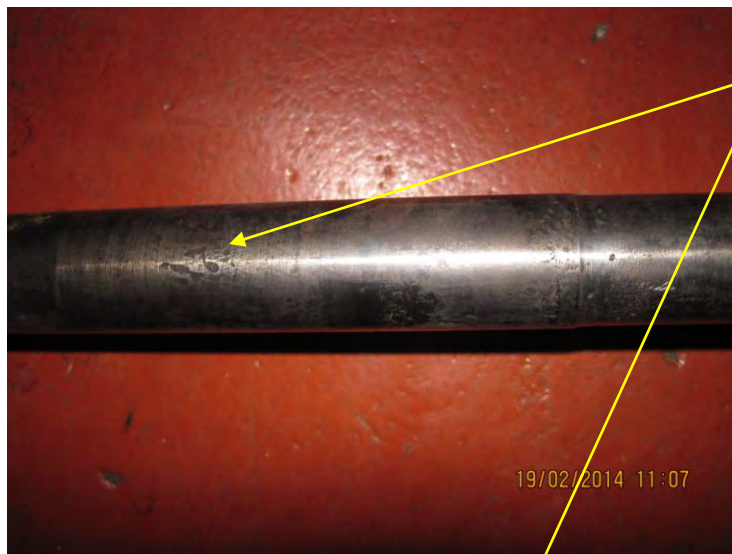
**Pitting marks were observed on valve spindle and valve cone during our visit in some exhaust and inlet valves.**

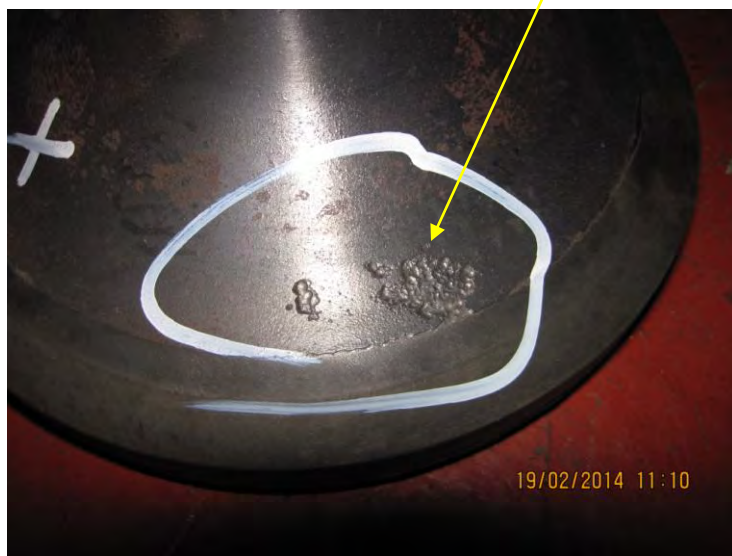
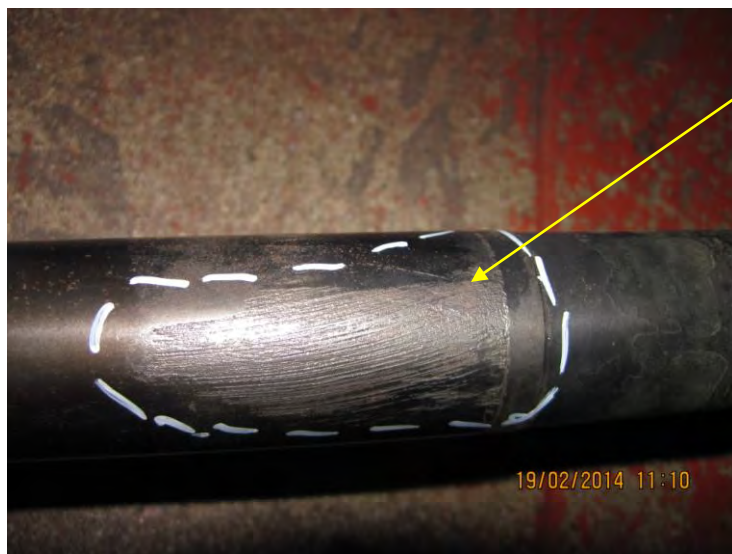
**Scuffing and fretting marks were noted on running surface of valve spindle.**

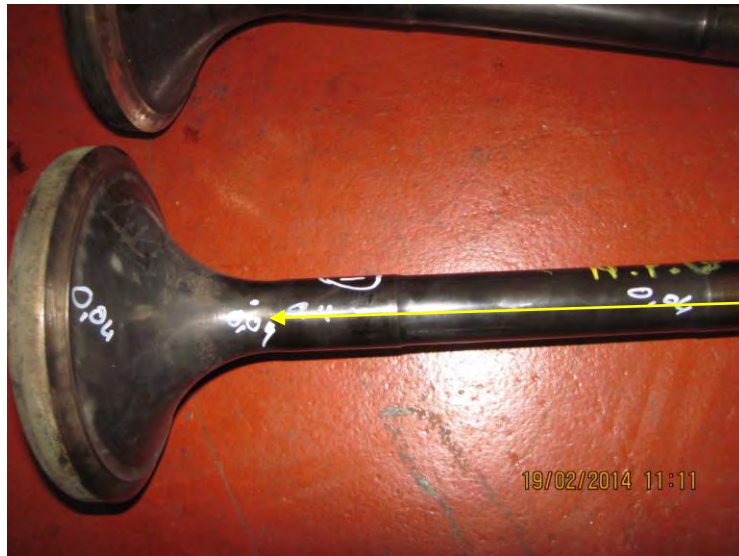
One valve was measured with 0.09mm as true running. Maximum permissible is 0.05mm. This valve should be discarded for any future use.

0.09mm measured by power plant staff.

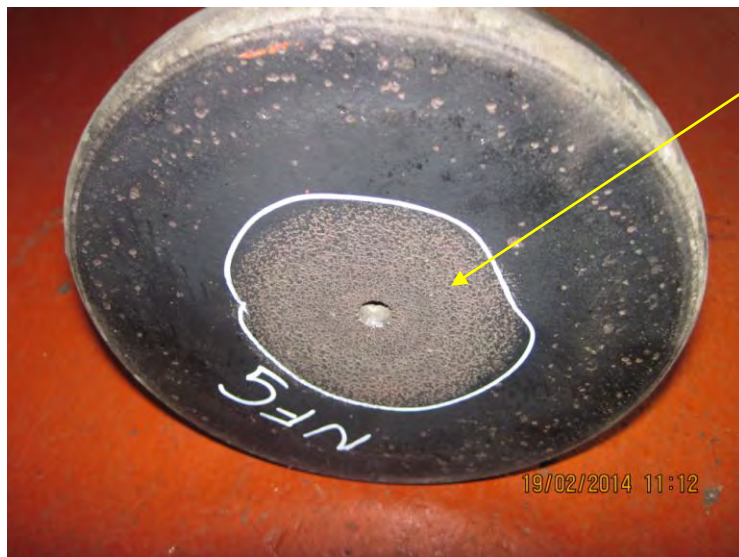
Maximum wear by hot corrosion on the valve plate should not exceed 3.0mm.

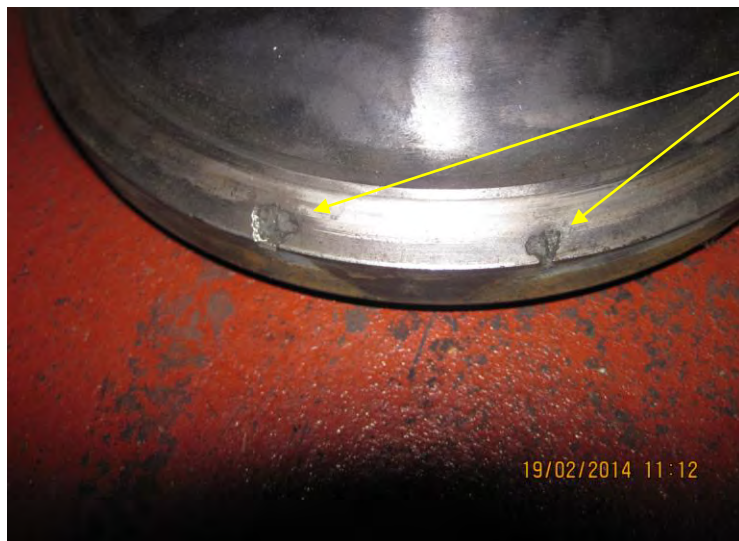
Valve seat damage by blow-by should be discarded of any repairing solution.

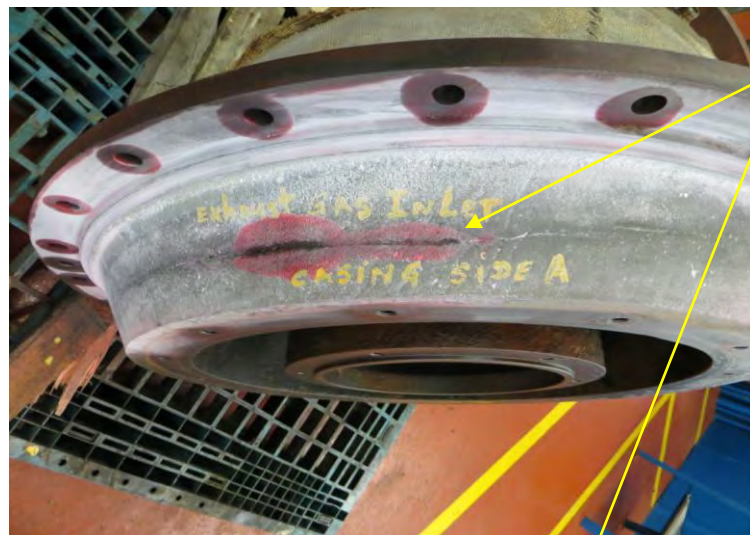
A crack was observed in the exhaust admission casing, A-bank, after 12,365hrs from the last exchange.

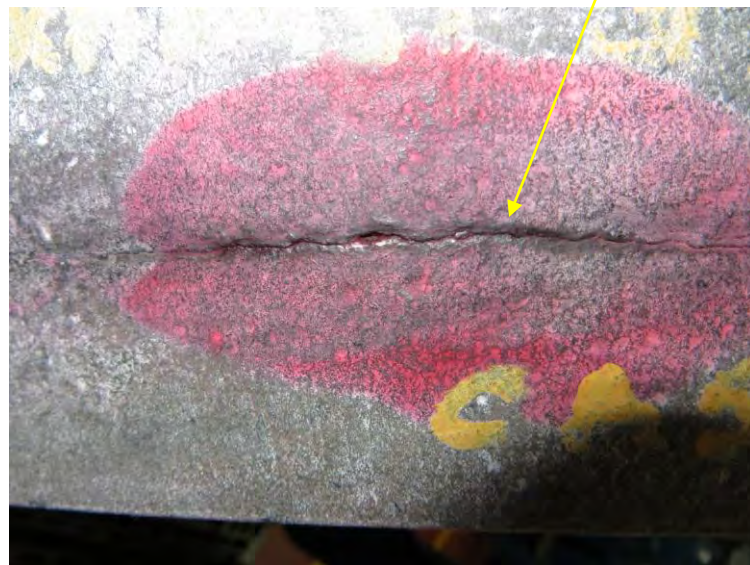
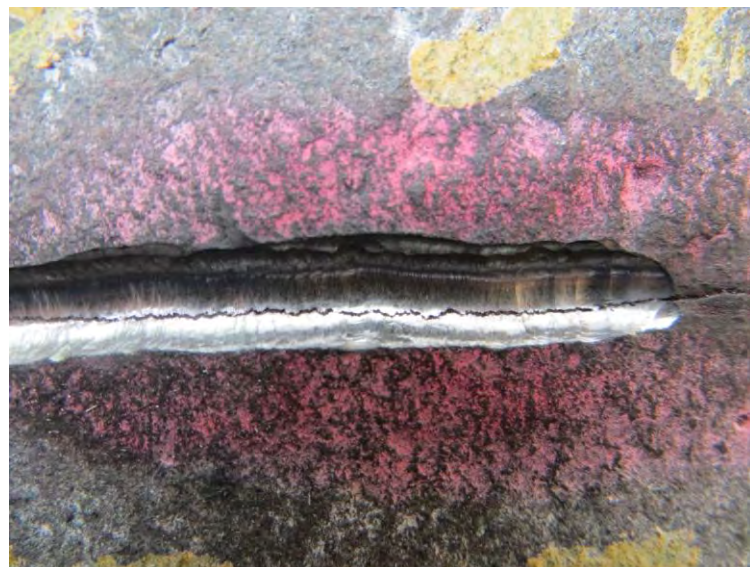
Grinding-off was done in order to determinate how deep that crack is around the casing.

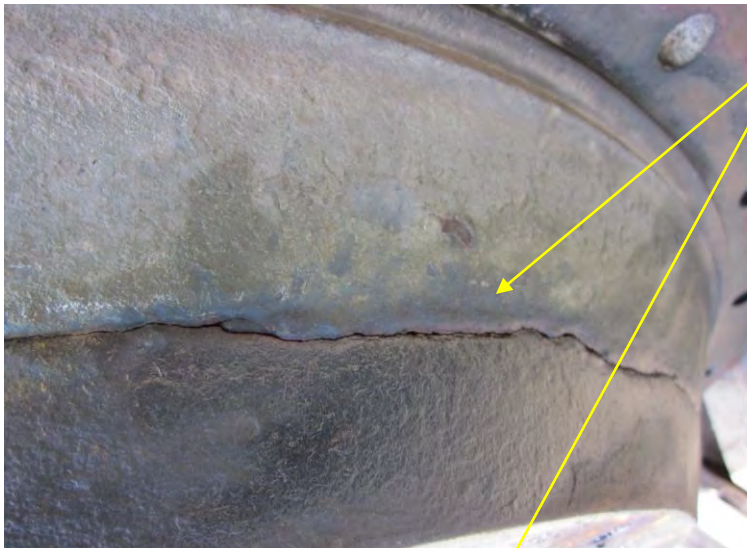
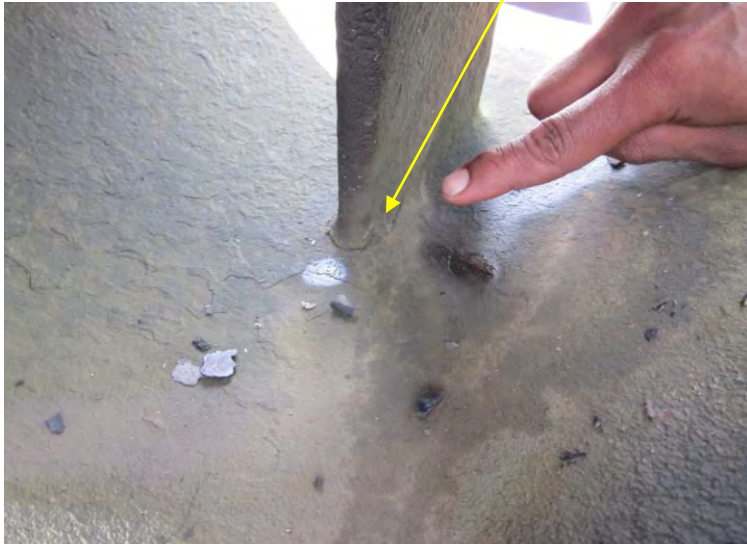
| | <p><b>Exhaust admission casing, A-bank, found with crack during overhaul of 66,747hrs.</b></p> |

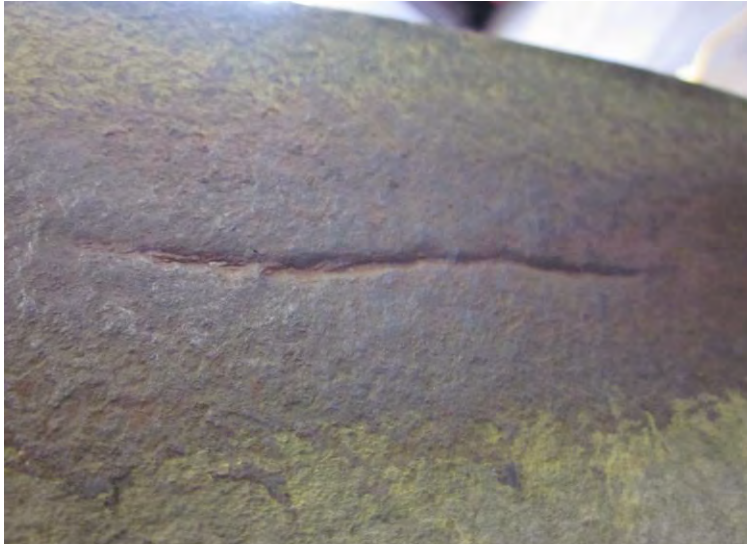
| | <p><b>Crack observed in the exhaust admission casing, B-bank during the same maintenance mentioned above (66,747hrs.).</b></p> <p><b>Both of them were exchanged by new spare parts (engine running hours in that moment 71,551hrs).</b></p> |
